# SUCCESS STORY

## TARGETED INSPECTION OF JACKET STRUCTURAL CLOSURE WELDS AND ACCESS WINDOW WELDS

# TARGETED INSPECTION OF JACKET STRUCTURAL CLOSURE WELDS AND ACCESS WINDOW WELDS

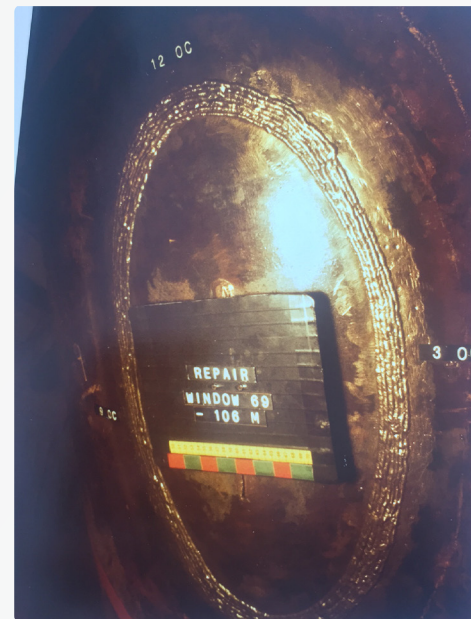
The Access Windows were cut into the jacket to allow internal backfill welding to be conducted during the jacket manufacture. These Access Windows are of differing geometries, so no two welds are the same. Therefore, as part of the structural integrity plan, they require regular inspection for the identifying of cracks emanating from the apex region of each weld.

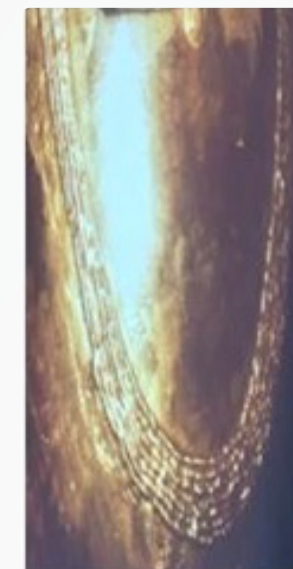
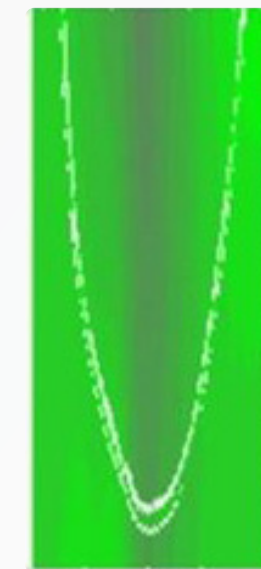
Sonomatic already had the MAG-Rover in service, this was ideal for ROV deployed inspection of Closure Welds. However, the awkward geometries of the AWW's took more consideration. A bespoke tool was designed and developed by Sonomatic with 5 axis of control that can deploy TOFD, 0° and Angle Shear Wave Pulse Echo in one deployment from the platform from a Comanche ROV. The tool has the capability to inspect the apex of each window weld and 250 mm either side of this region.

The inspection process first requires 0° inspection of weld area to map out the geometry. Using sophisticated software, the information collected is then utilised to plot out the weld profile to support the TOFD and Pulse Echo Inspections ensuring the probe assemblies are driven tangentially to the weld centreline around the weld apex.
